Your Inspection Report

Elmgrove Park
Rochester, NY

INSPECTION DATE:
Thursday, January 24, 2008

RE: Report No. 1048, v.3
Elmgrove Park
Rochester, NY
14624

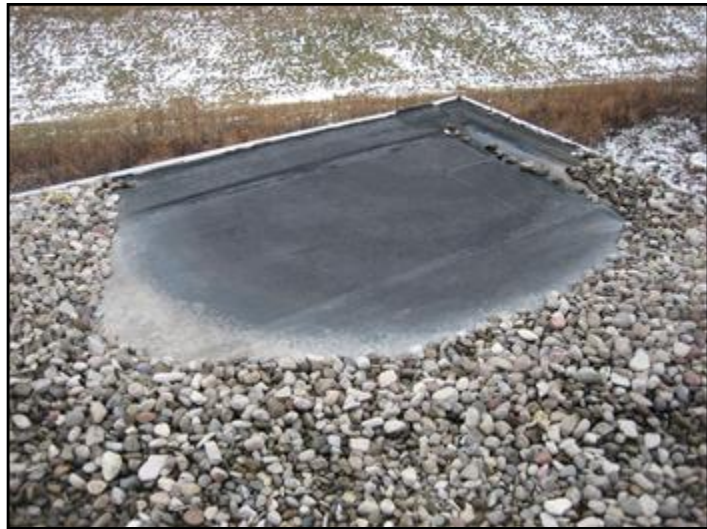
Condition: • Gravel erosion

Implication(s): Possible roof punctures, UV light damage

Location: Various

Task: Replace

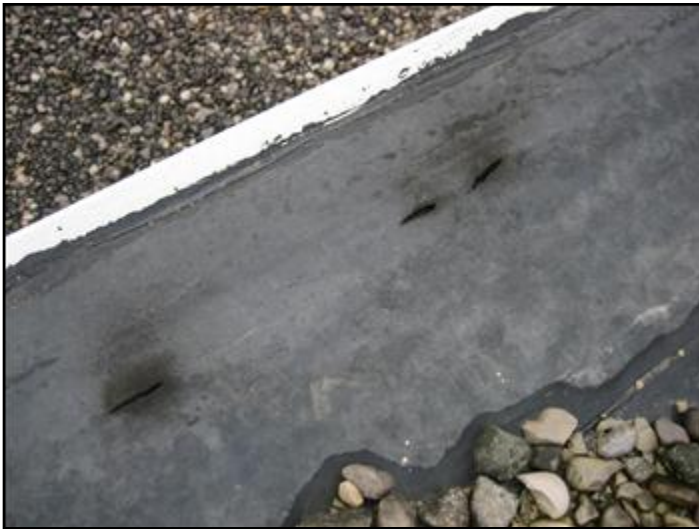
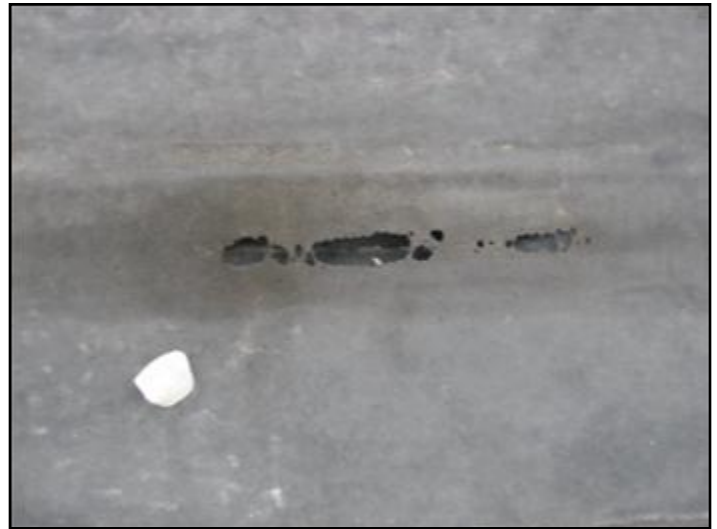
Condition: • [Damage, punctures, tears](#)

Location: Various

Task: Further Evaluation / Repair

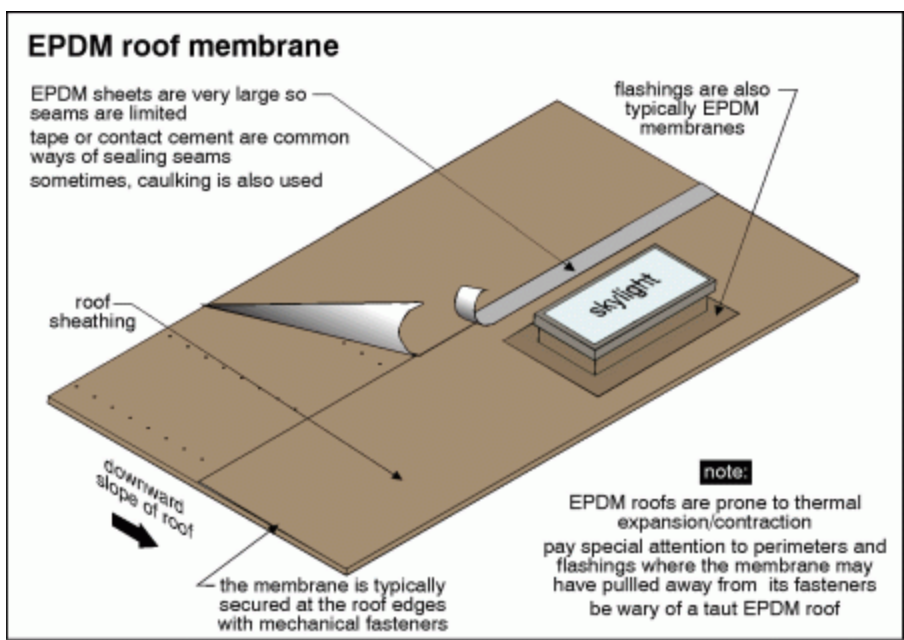
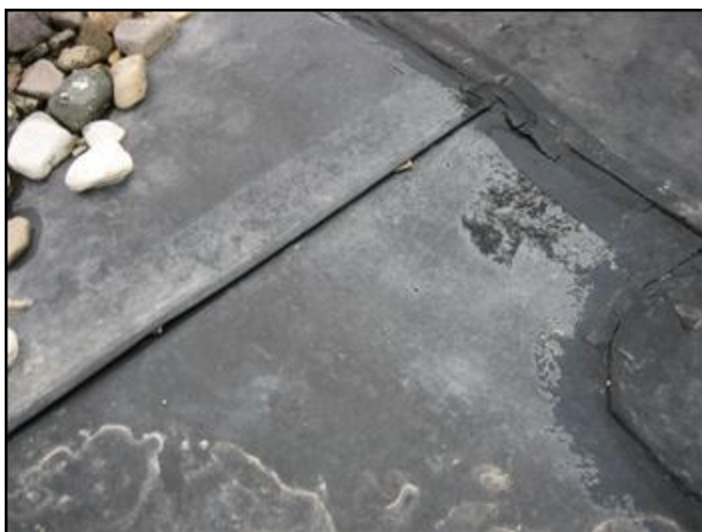
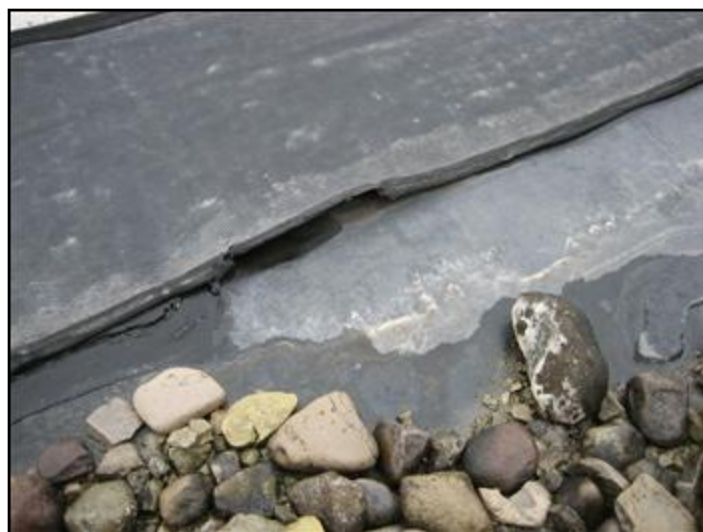
Condition: • [Openings at seams or flashings](#)

Location: Various

Task: Further Evaluation / Repair

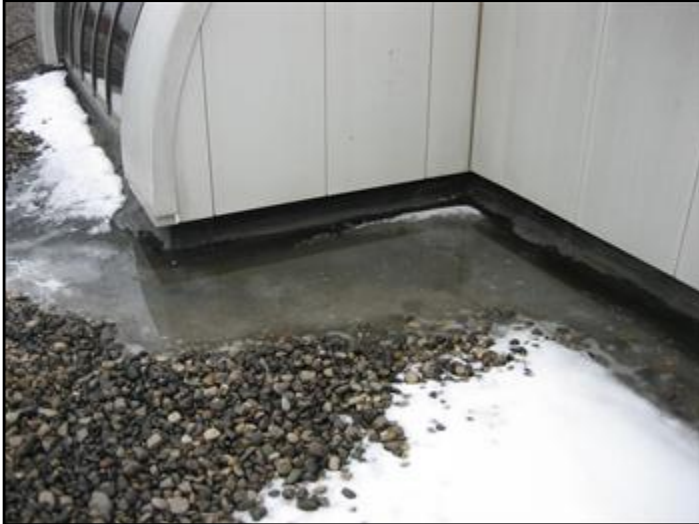
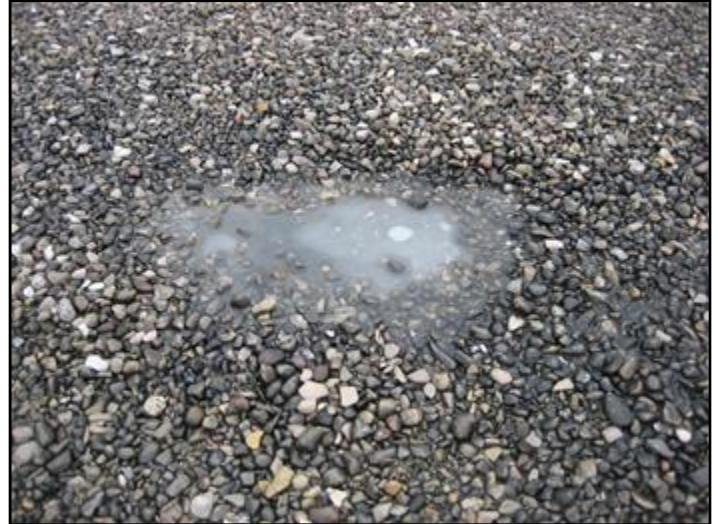
Condition: • [Ponding](#)

Location: Various

Task: Keep drains clean

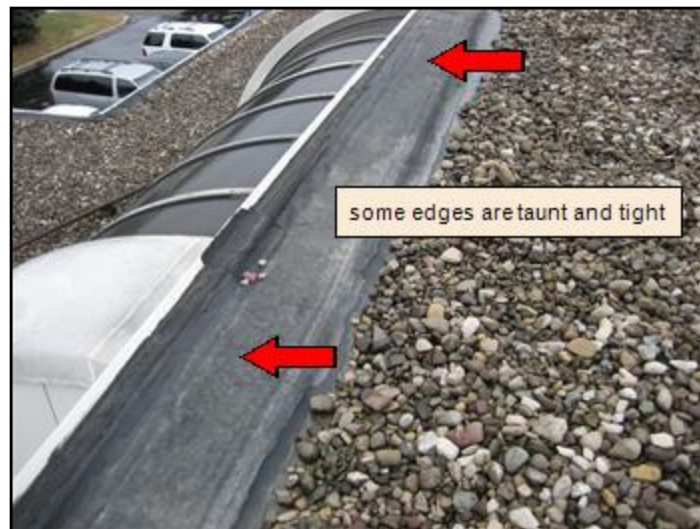
Condition: • [Taut, tenting](#)

Location: Various

Task: Further evaluation

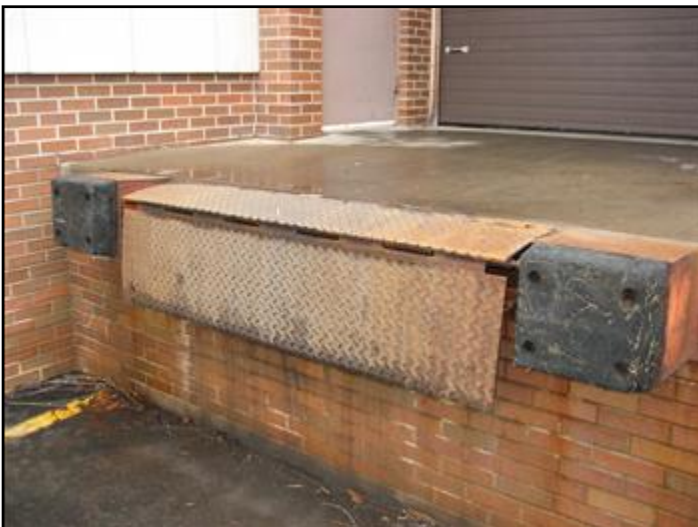
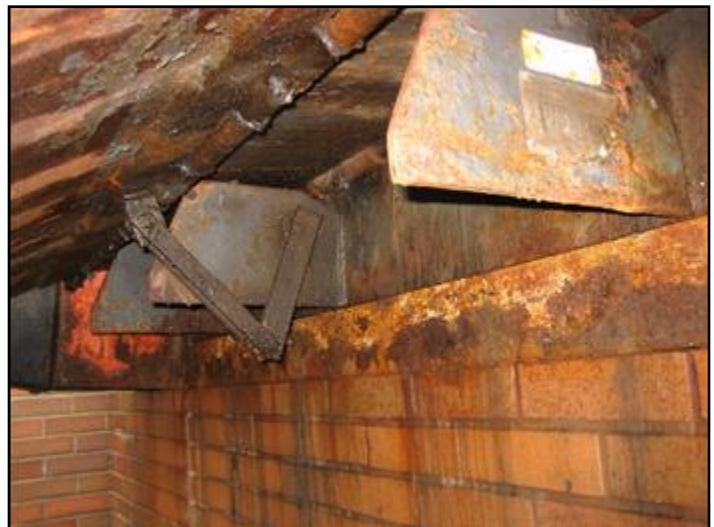
• Aged loading dock levelers and bumpers

Implication(s): Non-working levelers

Location: South Exterior

Task: Further evaluation

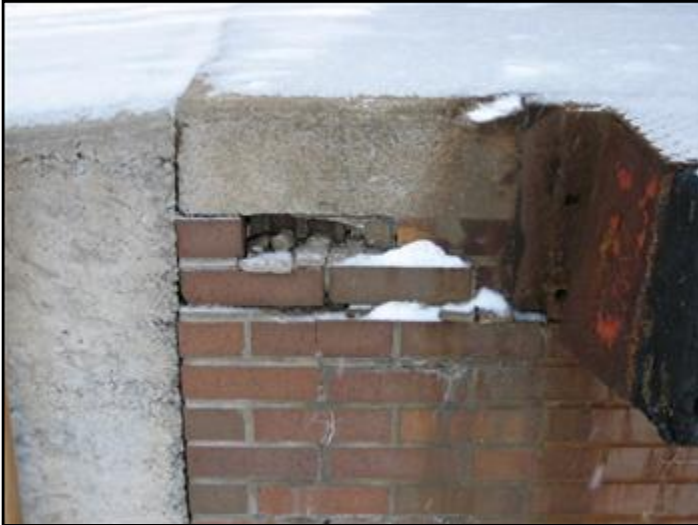
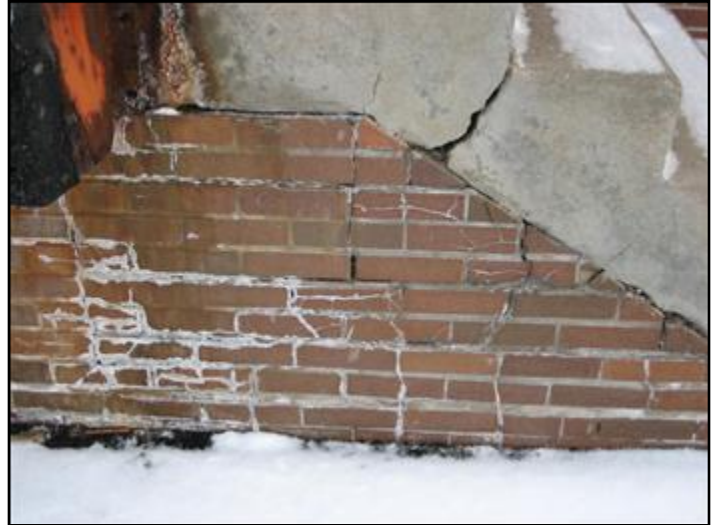
Walls \ Metal siding**Condition:** • [Mechanical damage](#)**Location:** South Exterior**Task:** Paint**Time:** Immediate**Cost:** Minor**Note:** dented and rusted**Walls \ Brick, stone and concrete****Condition:** • Poor seal at penetrations**Location:** East Exterior**Task:** Repair**Time:** Immediate**Cost:** Minor**Condition:** • [Masonry deterioration](#)**Location:** South Exterior around docks and steps**Task:** Repair**Time:** Immediate**Cost:** Minor

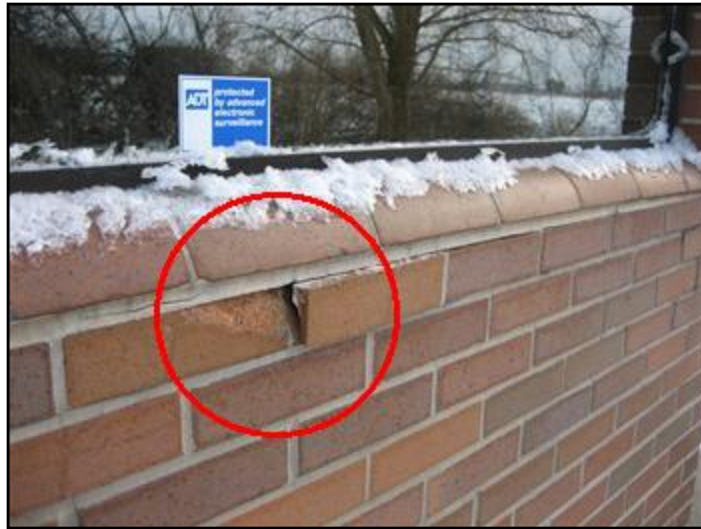
**Condition:** • [Spalling](#)**Location:** South Exterior near steps to dock 1**Task:** Repair**Time:** Immediate**Cost:** Minor

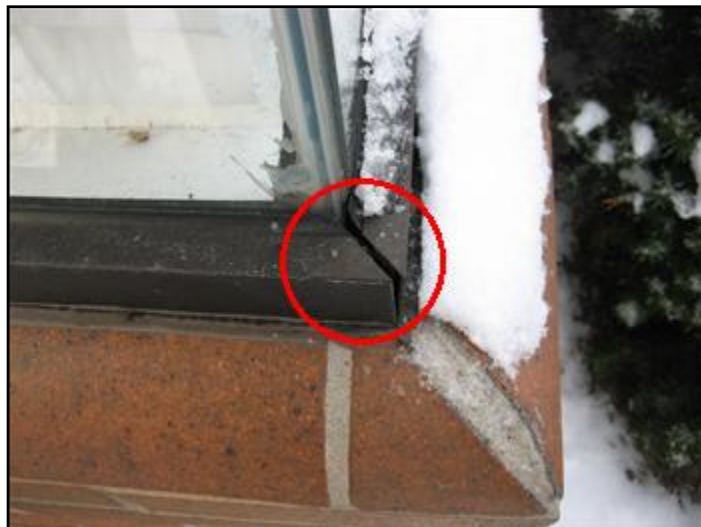
Condition: • [Caulking missing, loose or deteriorated](#)

Location: Various Exterior

Task: Improve

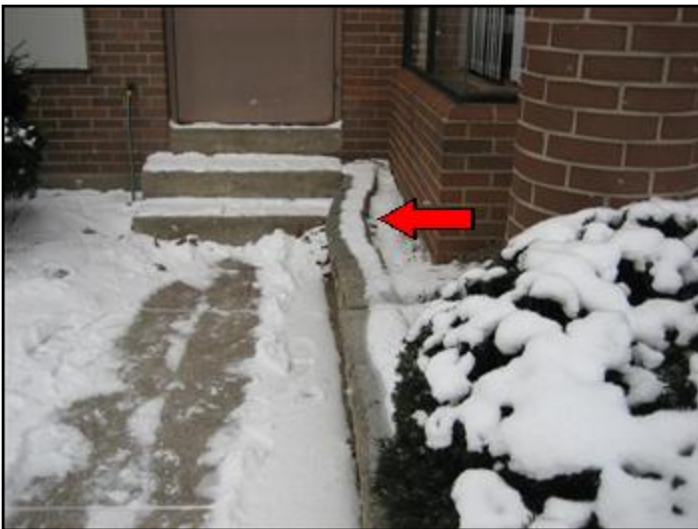
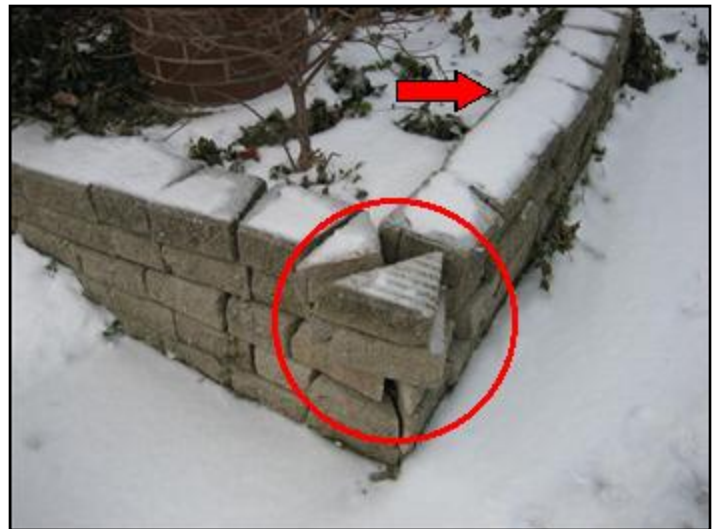
Condition: • [Leaning](#)

Location: East, North Exterior

Task: Repair

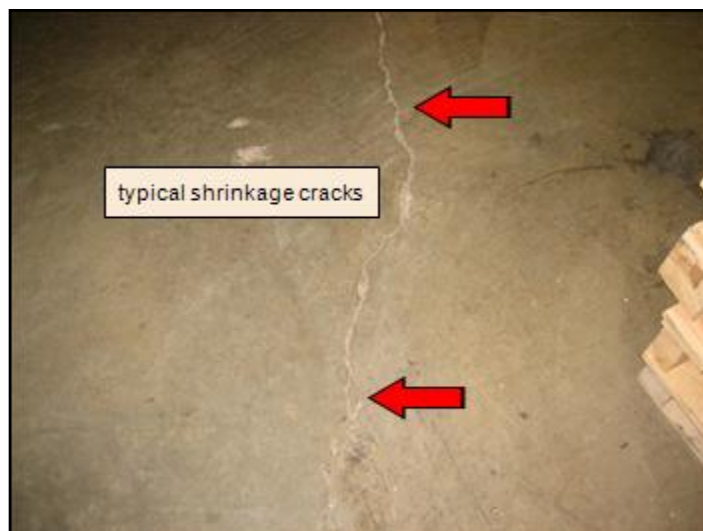
- Floors \ Concrete slabs**
- Condition:** • [Cracked](#)
- Location:** Various
- Task:** Monitor
- Note:** typical - cosmetic

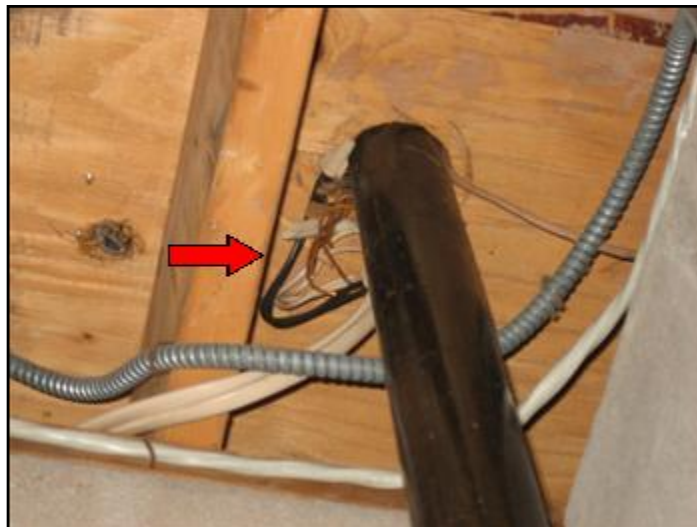
Condition: • [Exposed on walls or ceilings](#)

Location: East Utility room

Note: loose ended wire in ceiling by gas main

Task: Further evaluation

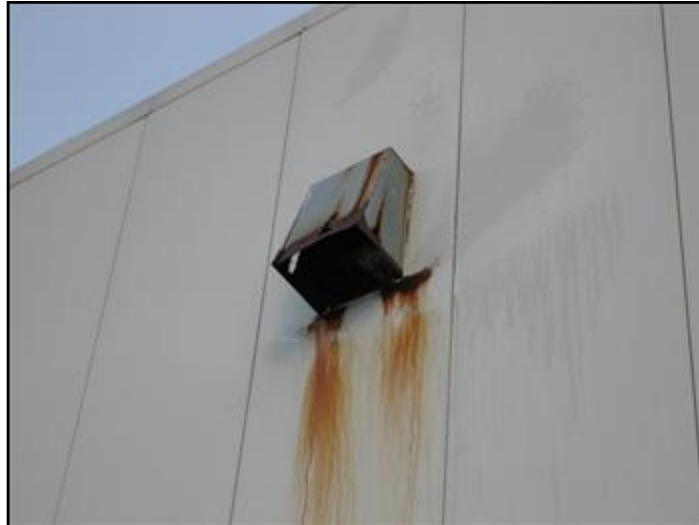
- Exhaust hood rusted out

Location: South Exterior

Task: Replace

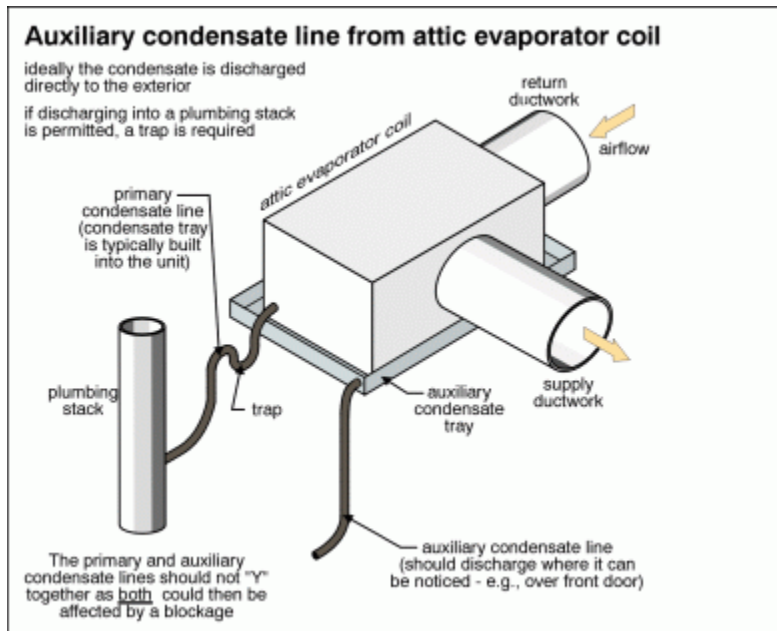
Condition: • [No auxiliary pan](#)

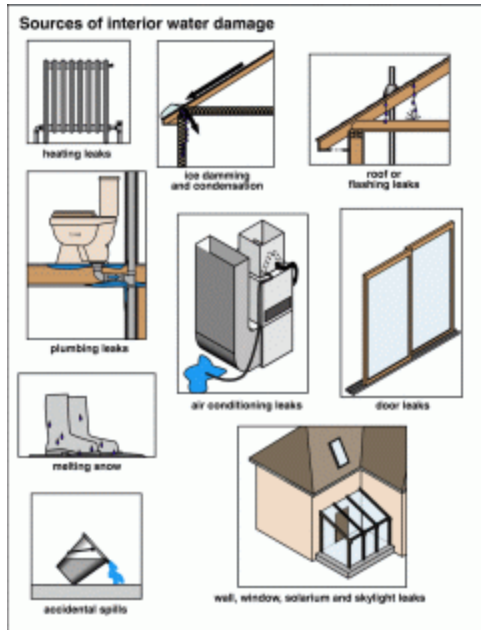
Condition: • [Water damage](#)

Note: several stained and missing ceiling tiles, many seem to be around skylights and overhead heating systems

Task: Replace
