Your Inspection Report

123 Sample Avenue
Rochester, NY

INSPECTION DATE:
Saturday, November 17, 2007

RE: Report No. 1003, v.7
123 Sample Avenue
Rochester, NY
14618

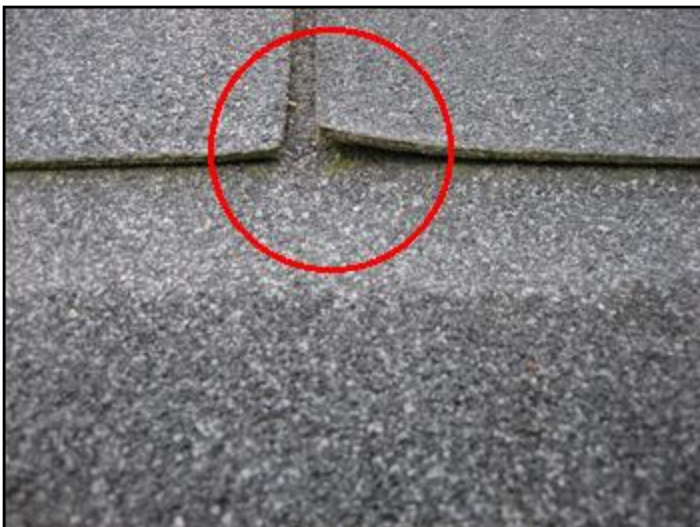
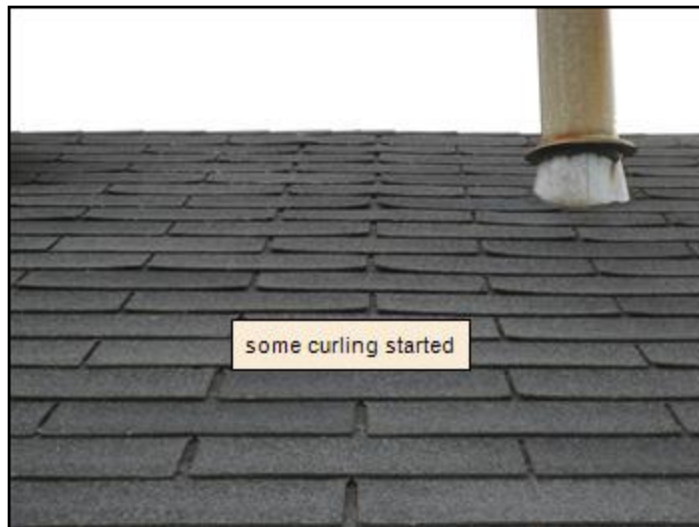
- Sloped roofing \ Asphalt shingles**
- Condition:** • [Near end of life expectancy](#)
- Location:** Throughout
- Task:** Replace
- Time:** Less than 2 years
- Cost:** Major

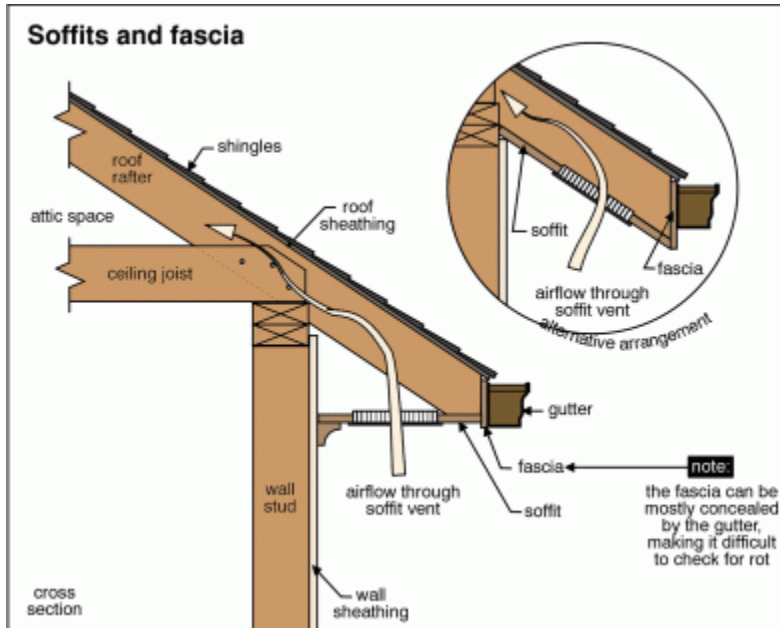
Walls \ Soffits and fascia

Condition: • [Vents missing, ineffective](#)

Location: Throughout Attic

Task: Improve

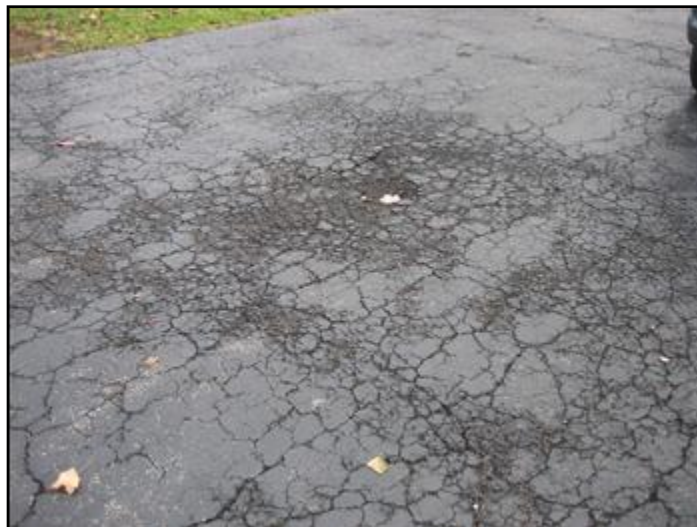
Landscaping \ Walk and driveway

Condition: • [Cracked or damaged surfaces](#)

Note: Driveway is in poor condition.

Task: Replace

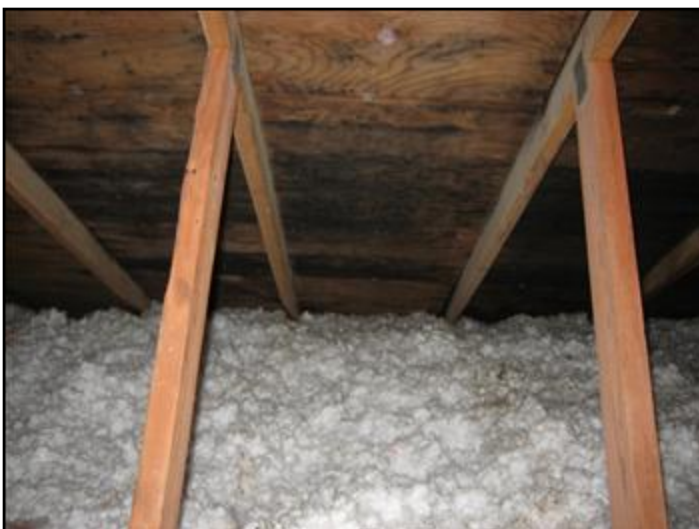
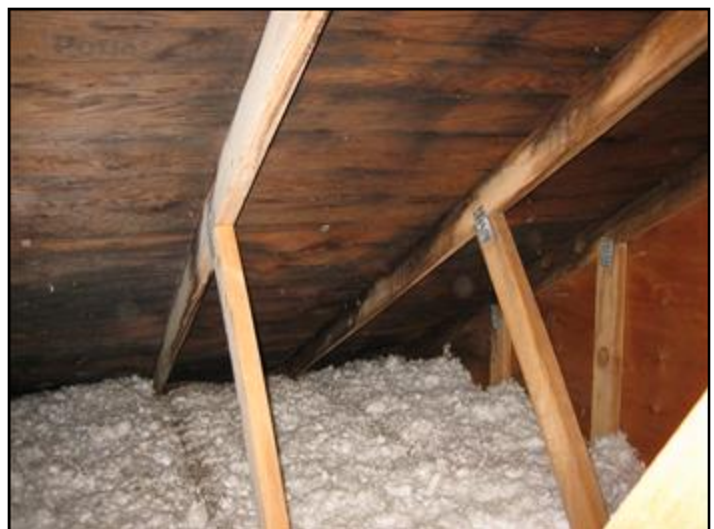
- Roof framing \ Sheathing**
- Condition:** • [Mold](#)
- Location:** Throughout Attic
- Task:** Further evaluation
- Time:** Immediate
- Cost:** Major
- Note:** What is thought to be mold has blackened the plywood sheathing

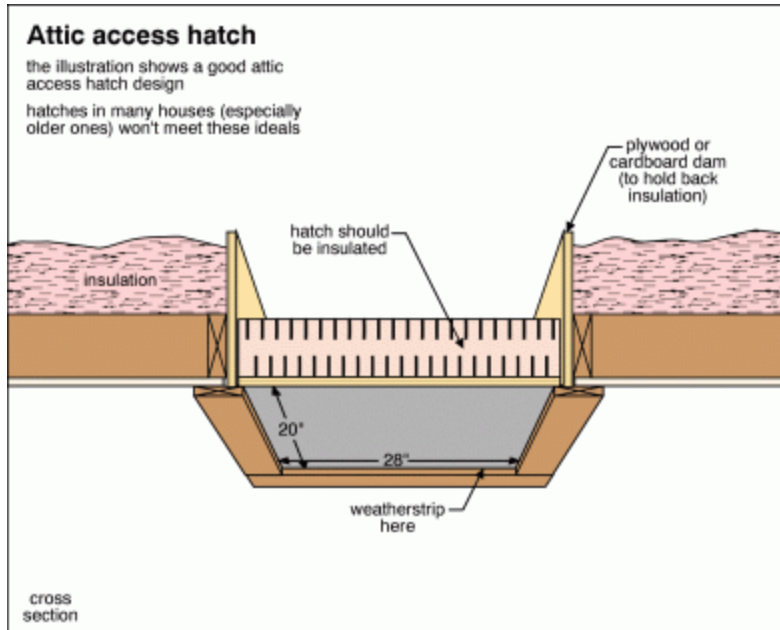
- Attic/roof \ Hatch**
- Condition:** • [Not insulated and not weatherstripped](#)
- Location:** Attic
- Task:** Improve
- Time:** Immediate
- Cost:** Minor

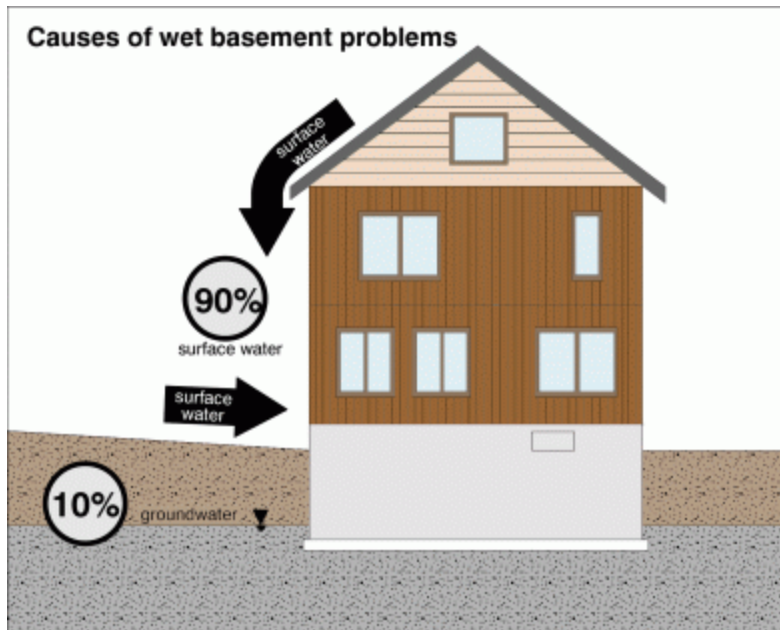
Basement \ Wet basements - vulnerability

Condition: • [Poor grading](#)

Location: Various Yard

Task: Improve
